Manhole Inspection Summary

Manhole # S15AA_012MH

Inspection ☐ Is Incomplete Rating: **4) Poor**

Location Address: **927 CLAYMONT AVE**

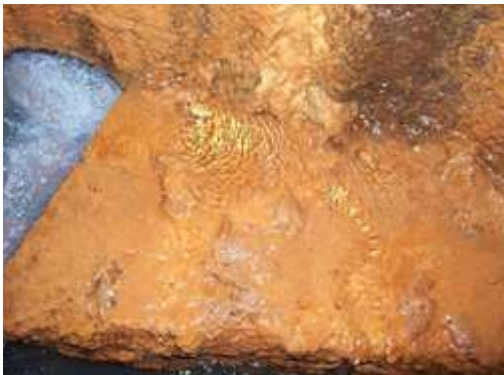
Defect 3

Condition: ☐ Sound ☐ Cracked ☐ Root Intrusion ☐ Deteriorated ☒ **Leaks** ☐ Debris

INFILTRATION RUNNER AND LEAKS-BENCH

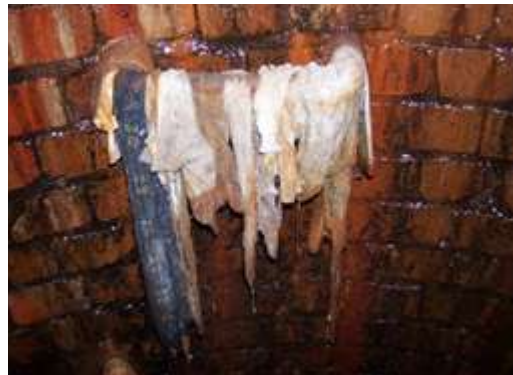
Defect 2

☒ **Evidence Of Surcharge** Depth: **2** (ft.) ☐ Active Surcharge Present

EVIDENCE OF SURCHARGE

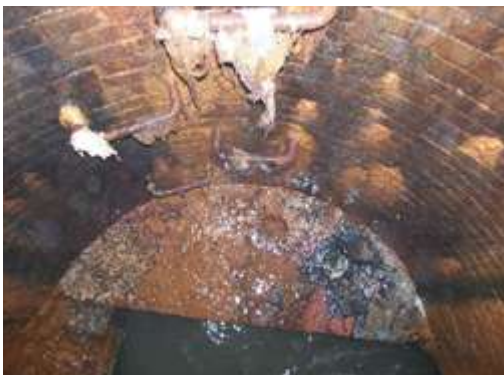
Defect 1

Infiltration: ☐ None ☐ Joint ☐ Cracks ☐ Mortar ☐ Roots ☒ **Wall**

INFILTRATION RUNNER- BARREL

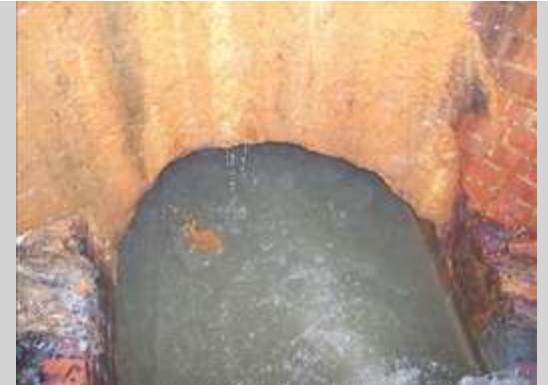
12 O'Clock Outflow

33 in. Circular Gravity Sewer
Pipe Out @ 12 O'Clock

Pipe Height: (in.) Direct
Pipe Material: **Clay** ☐ Pipe Lined
Invert Depth: **31.67** (ft.) Flow Characteristics: **Fast**
Deposits: ☒ None ☐ Mud ☐ Sludge ☐ Debris ☐ Grease
Silt Depth: (in.) Deposits Extent:
Infiltration: **Evidence** Pipe Seal Cond: **Unknown**

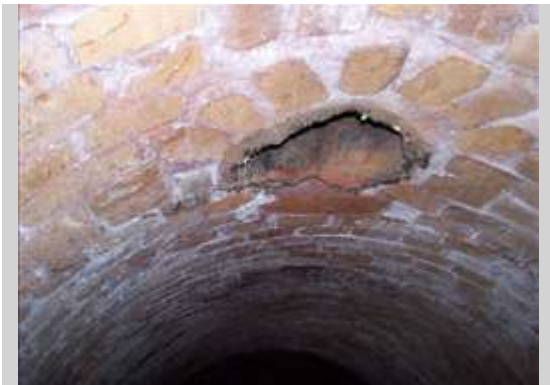
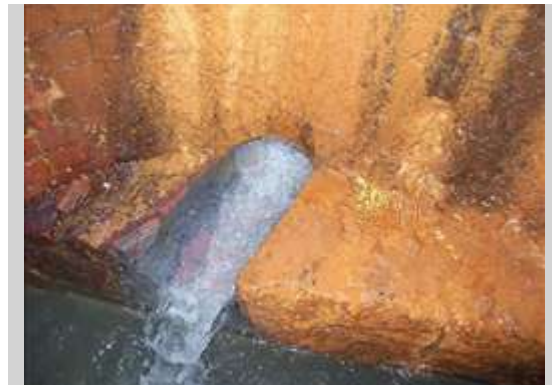
3 O'Clock Inflow

8 in. Circular Gravity Sewer
Pipe In @ 3 O'Clock

Pipe Height: (in.) Direct
Pipe Material: **Clay** ☐ Pipe Lined
Invert Depth: **9.72** (ft.) Flow Characteristics: **Fast**
Deposits: ☒ None ☐ Mud ☐ Sludge ☐ Debris ☐ Grease
Silt Depth: (in.) Deposits Extent:
Infiltration: **None** Pipe Seal Cond: **Sound**

Drop: **Outside Direct**

Drop Condition: **Open**

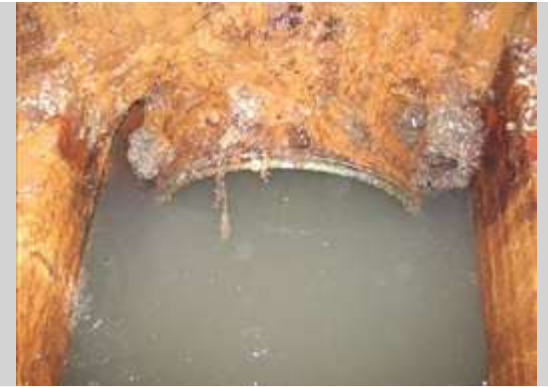
6 O'Clock Inflow

33 in. Circular Gravity Sewer
Pipe In @ 6 O'Clock

Infiltration: **Evidence** Pipe Seal Cond: **Unknown**
